# Safety Inspection Report

Annual Inspection

## Play Area

Innsworth Parish Council

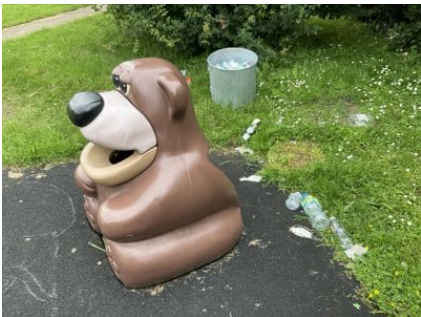
Minor repairs are needed.

Read the notes for further action., Repair.

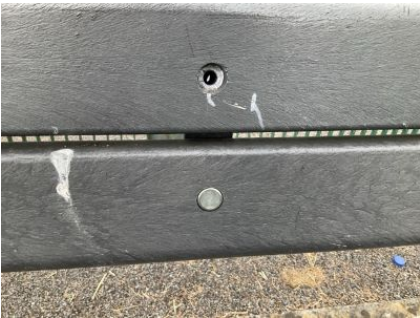
| Fixtures loose or missing. |
| Also slightly loose in ground. |

| Tighten/replace. |

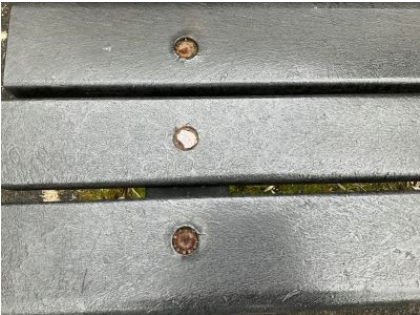
Item has corrosion.

Fixings corroding.

Treat and repair.

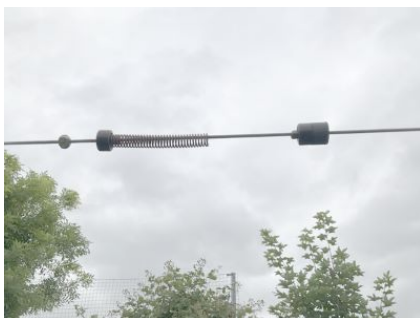
Moderate repairs are needed.

## Repair.

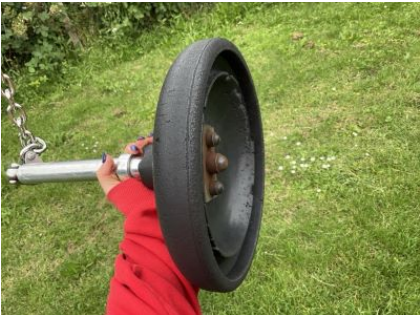
| Description |
|---|
| Fixtures loose or missing. |

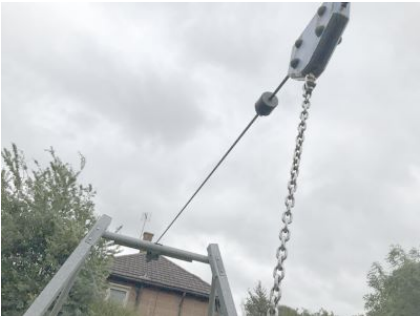
| Description |
|---|
| Cables have been known to fail under load due to wear and corrosion. This is generally where the cable enters into a tube, top bar, sleeve or similar, where the wire is in contact and wears and frays over time, but can happen anywhere on the cable. It is important to inspect any hidden parts at least annually. Damaged cables require replacement. This cannot be determined during an annual inspection, and is excluded from our inspection. This can lead to a high risk if no action is taken. Refer to the manufacturer's instructions to ensure the correct check is carried out. |

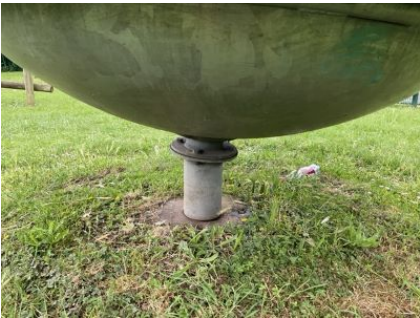
The bearings are worn.

Replace the worn bearings.

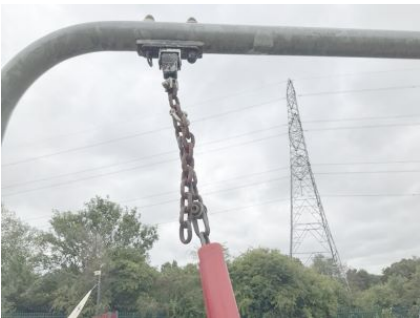
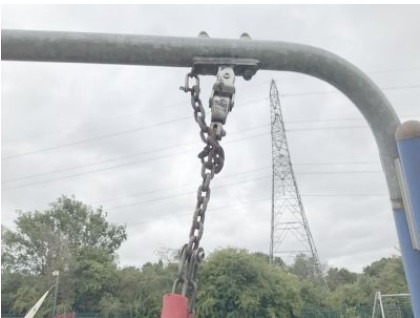
A secondary support device is required to prevent collapse in the event of supporting component failure.

One is broken and the other is twisted. Repair/replace.

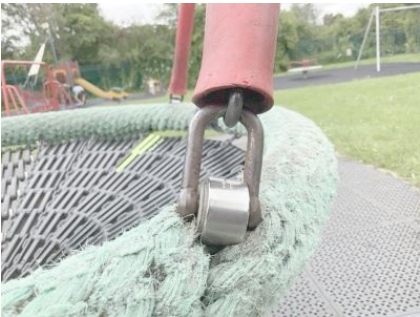
Some chain wear.

Monitor for further deterioration and replace before 40% wear.

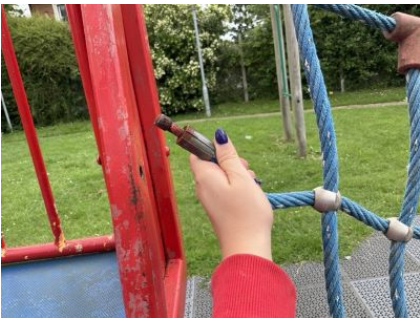
Fixtures loose or missing.

Tighten/replace.

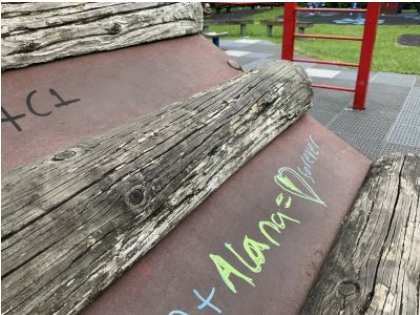
Timber is decayed.

Timber is not in a good condition and is splintering.

Replace affected parts.

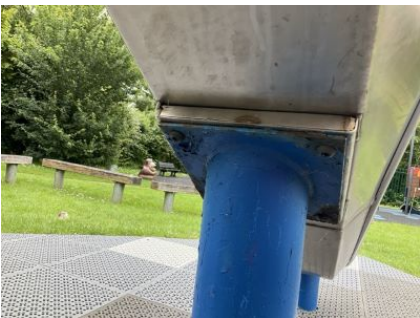
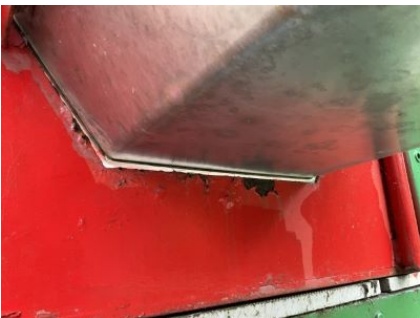
Item has corrosion.

Treat and repair.

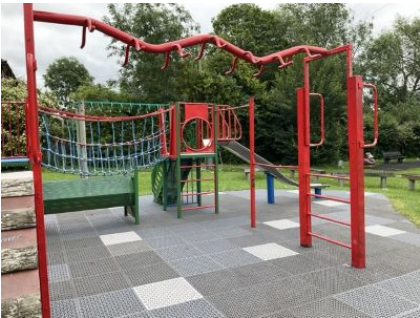
Overhead ladders and rings provide significant play value and benefits to children, and with it the risk of falling. Ensuring the surface remains in good condition will help to keep the correct balance between benefits and risk.

If possible, on angled or S-shaped bars, consideration should be given to level bars with firm grips and even spacings. The protective surface under all bars and rings must be kept in good condition.

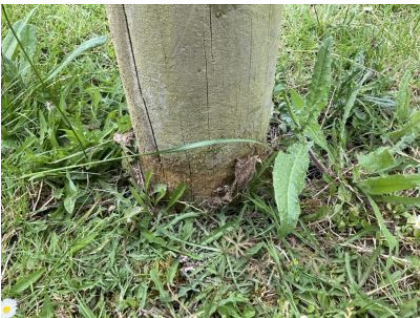
Strimmer damage is present on posts, allowing water to enter and timbers to soften. It can also remove the protective envelope around the timber. Prevent further damage and check timbers for decay throughout the year.

Prevent further damage.

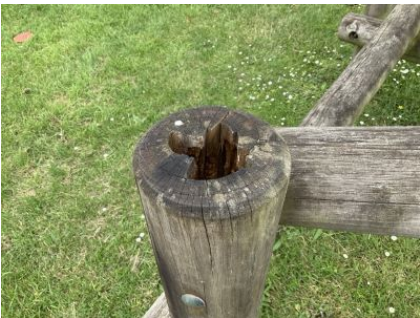
Timber is decayed.

Replace affected parts.

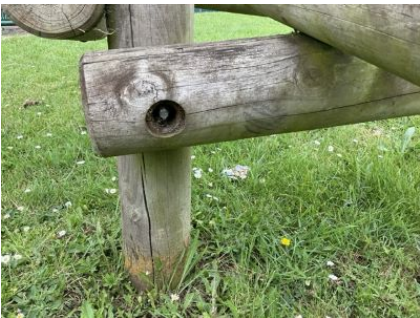
Cap missing.

Replace.

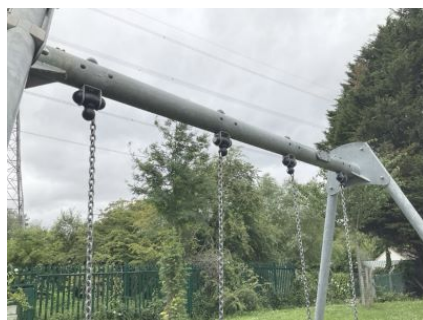
The covers should be removed from the fitting at the top of the chain annually and the shackle bolt should be checked for wear. Check the security of the fittings too.

Replace at 70% of original diameter (30% wear). Check the security of the fittings.

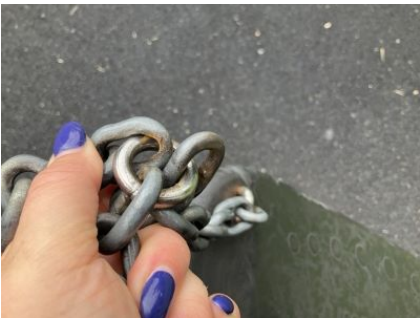
Some chain wear.

Monitor for further deterioration and replace before 40% wear.

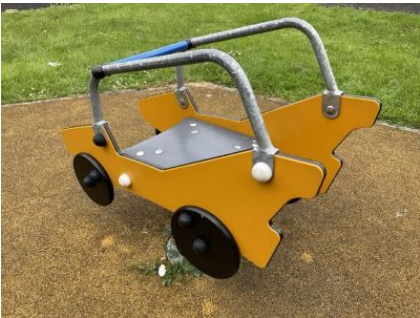
Fixtures loose or missing.

Panels loose to seat/spring.

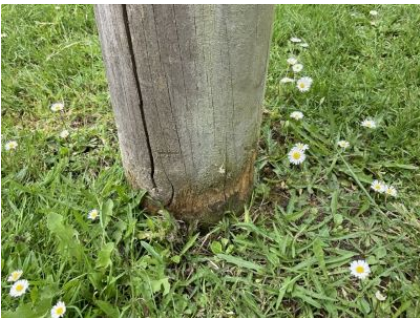
Strimmer damage is present on posts, allowing water to enter and timbers to soften. It can also remove the protective envelope around the timber. Prevent further damage and check timbers for decay throughout the year.

Prevent further damage.

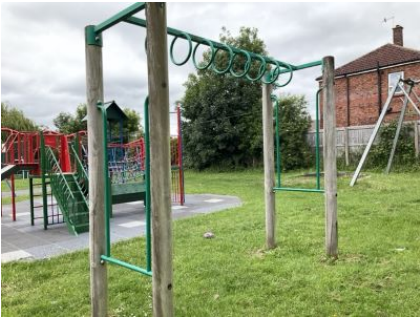
Overhead ladders and rings provide significant play value and benefits to children, and with it the risk of falling. Ensuring the surface remains in good condition will help to keep the correct balance between benefits and risk.

If possible, on angled or S-shaped bars, consideration should be given to level bars with firm grips and even spacings. The protective surface under all bars and rings must be kept in good condition.

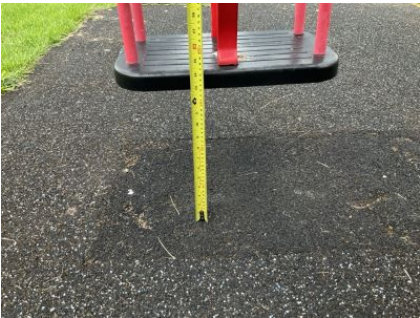
| Description | Tasks | Risk score |
|---|---|---|
| Seat(s) set at incorrect height. | Adjust to give a minimum of 350 mm clearance for standard seats, and 400 mm for tyres, baskets and other groups seats. We recommend a minimum of 500 mm seat height to reduce foot drag and surface wear. | 6 |

Adjust to give a minimum of 350 mm clearance for standard seats, and 400 mm for tyres, baskets and other groups seats. We recommend a minimum of 500 mm seat height to reduce foot drag and surface wear.

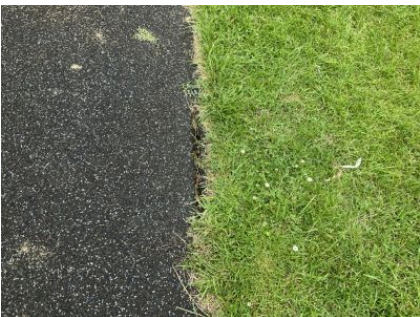
Shrinkage / separation of the surface. This may give a trip hazard.

Repair.

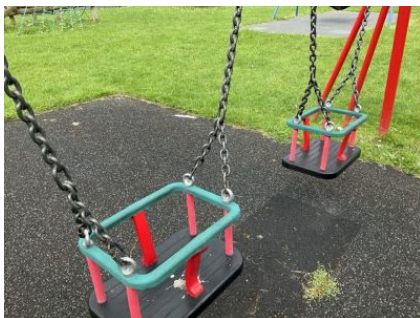
Loose swing seat eye-bolts.

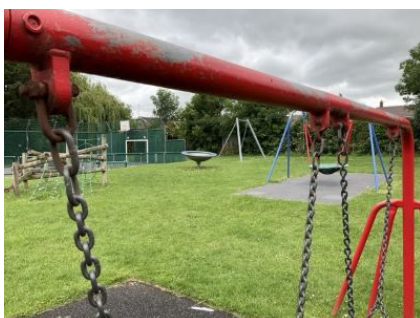
There is wear in the bushes.

Remove shackle bolt and check bush and shackle pin wear, replacing as necessary.
