# Safety Inspection Report

Annual Inspection

## Play Area

Innsworth Parish Council

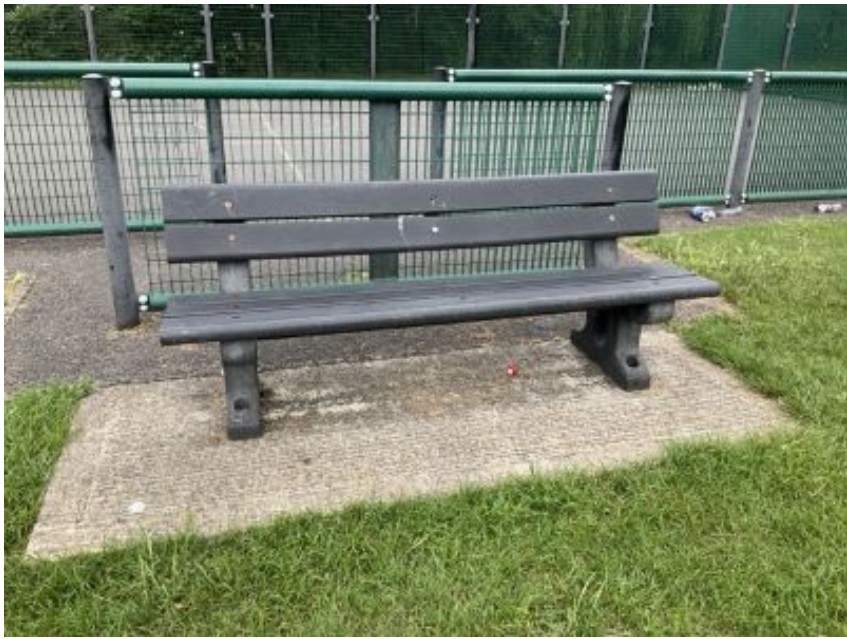
# Seating

| Fixtures loose or missing. |
| Also slightly loose in ground. |

Item has corrosion.

Fixings corroding.

| Tighten/replace. |

Treat and repair.

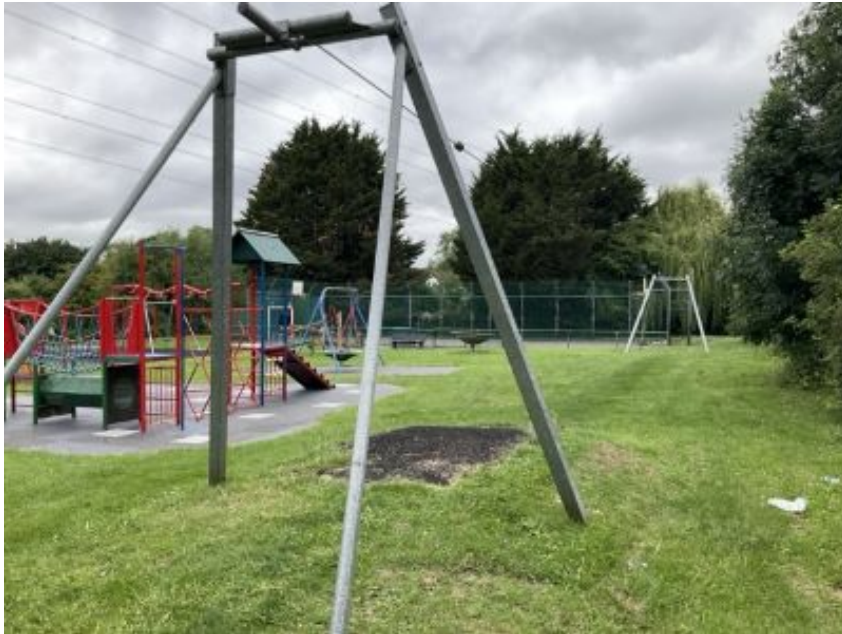
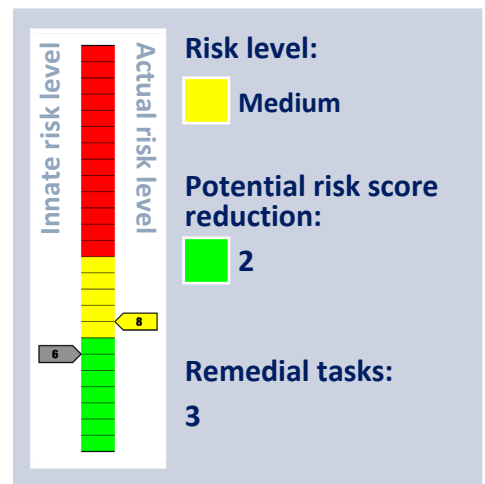
# Cableway

Moderate repairs are needed.

| Description |
|---|
| Fixtures loose or missing. |

| Description |
|---|
| Cables have been known to fail under load due to wear and corrosion. This is generally where the cable enters into a tube, top bar, sleeve or similar, where the wire is in contact and wears and frays over time, but can happen anywhere on the cable. It is important to inspect any hidden parts at least annually. Damaged cables require replacement. This cannot be determined during an annual inspection, and is excluded from our inspection. This can lead to a high risk if no action is taken. Refer to the manufacturer's instructions to ensure the correct check is carried out. |

## Repair.

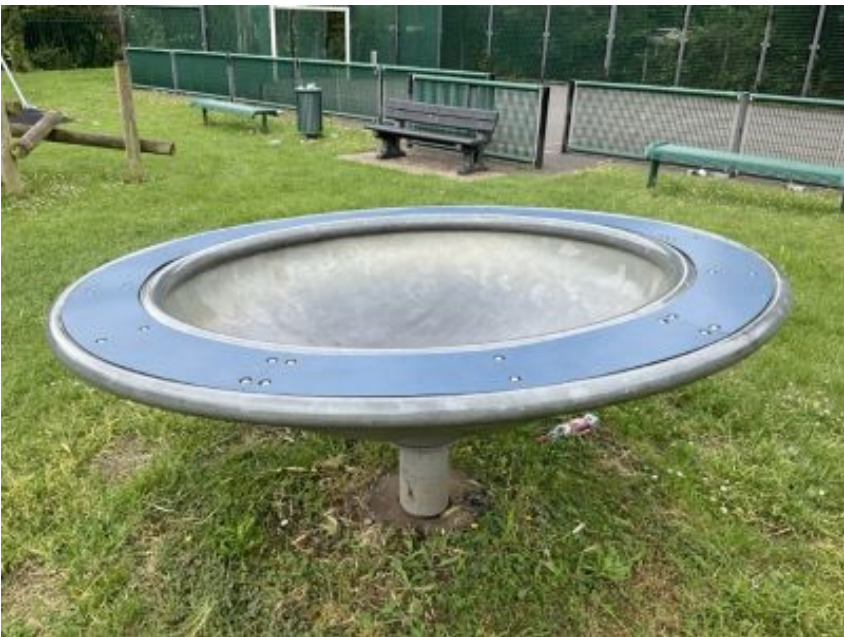
# Carousel - Bowl

The bearings are worn.

Replace the worn bearings.

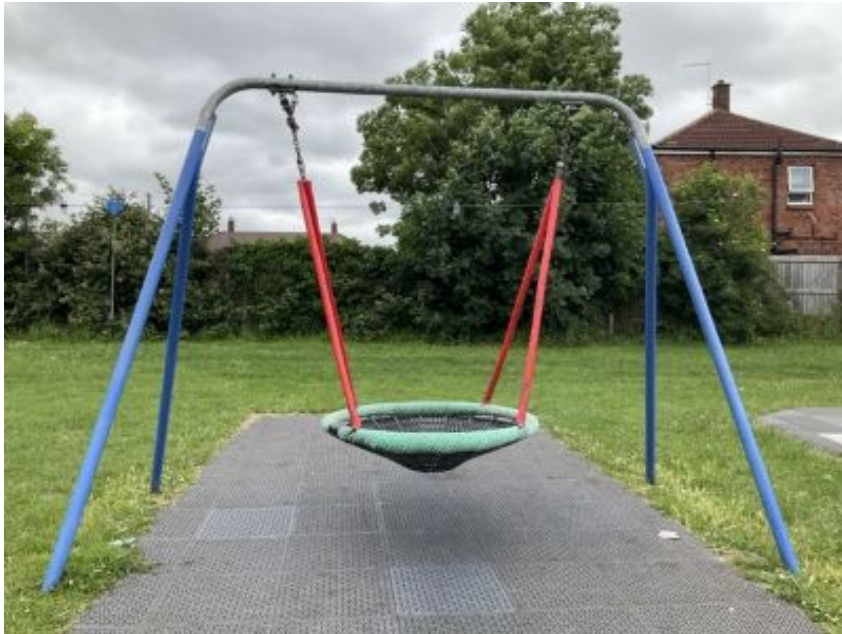
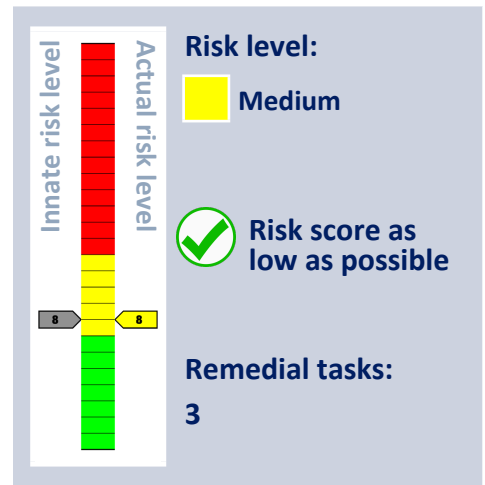
# Swing - Basket

1. A secondary support device is required to prevent collapse in the event of supporting component failure.

1. Some chain wear.
2. Chain covers prevent a thorough inspection of all chain links.

A secondary support device is required to prevent collapse in the event of supporting component failure.

One is broken and the other is twisted. Repair/replace.

Some chain wear.

Monitor for further deterioration and replace before 40% wear.

Remove chain covers to inspect according to manufacturer's instructions, and replace the covers when done.

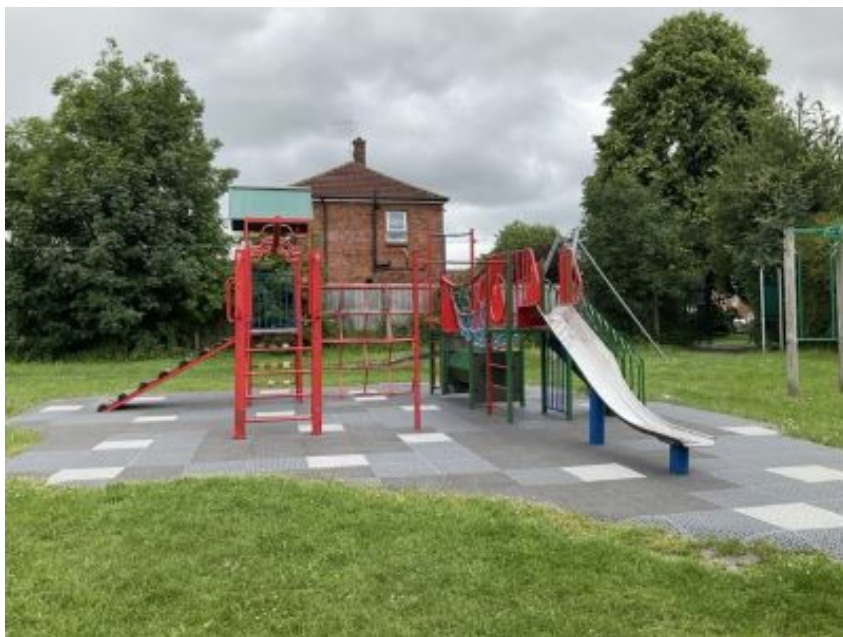
# Multiplay - Slide Climber

1. Fixtures loose or missing.
2. Exposed metal rope core(s).
3. Timber is decayed.
4. Item has corrosion.
5. Item is bent.
6. Overhead ladders and rings provide significant play value and benefits to children, and with it the risk of falling. Ensuring the surface remains in good condition will help to keep the correct balance between benefits and risk.

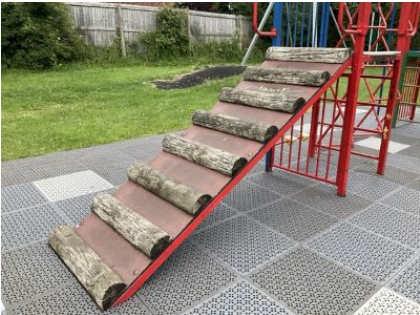
Timber is decayed.

Timber is not in a good condition and is splintering.

Risk score:  
 6

Replace affected parts.

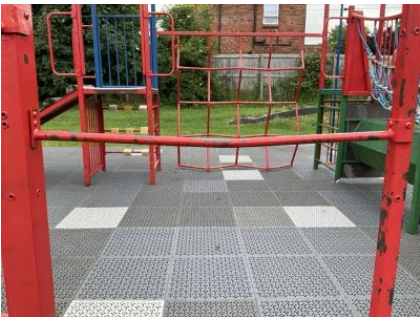
Item has corrosion.

Treat and repair.

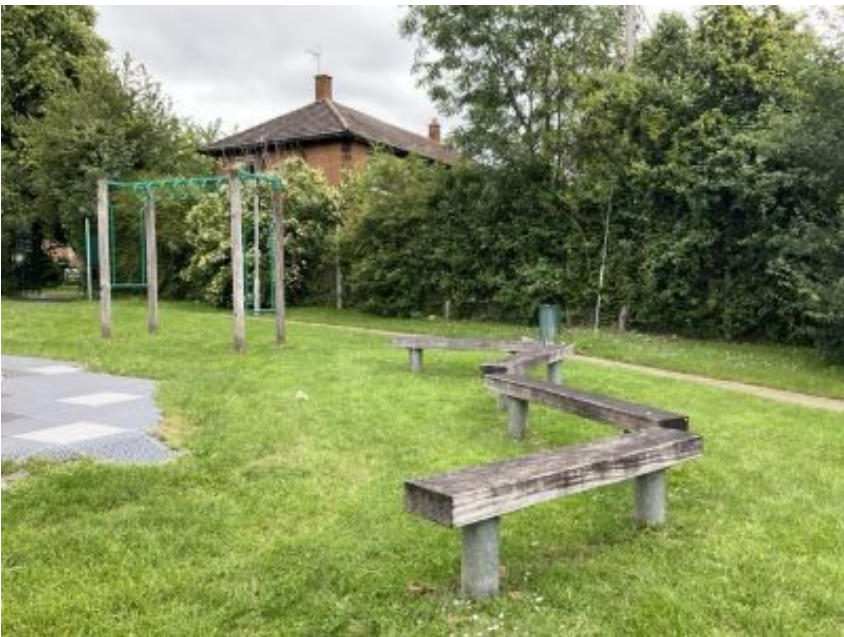
# Agility - Trim Trail

Strimmer damage is present on posts, allowing water to enter and timbers to soften. It can also remove the protective envelope around the timber. Prevent further damage and check timbers for decay throughout the year.

Prevent further damage.

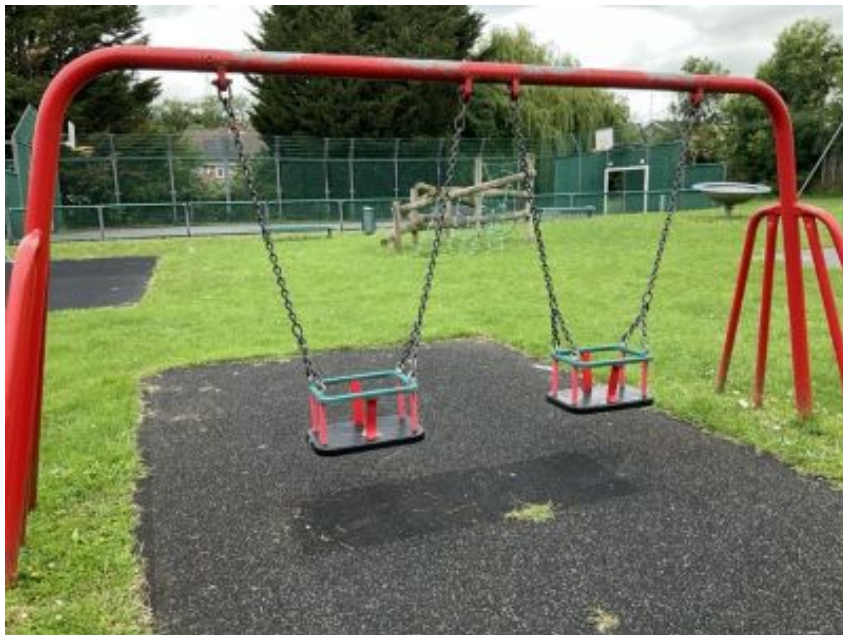
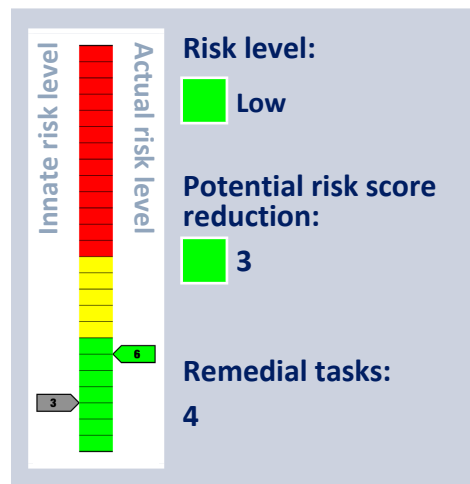
# Swing - Toddler - 1 Bay 2 Seat

1. Shrinkage / separation of the surface. This may give a trip hazard.
2. Loose swing seat eye-bolts.
3. There is wear in the bushes.

Shrinkage / separation of the surface. This may give a trip hazard.

Loose swing seat eye-bolts.

There is wear in the bushes.

Repair.

Remove shackle bolt and check bush and shackle pin wear, replacing as necessary.
